The 2006 Mesa County Irrigation Audit Program Final Report

Catch Cans in place for the Advanced Level Audit

Dr. Curtis E. Swift,
Colorado State University Cooperative Extension Agent & Certified Landscape Irrigation Auditor and Ardith Blessinger, Mesa County Irrigation Audit Specialist, Certified Landscape Irrigation Auditor

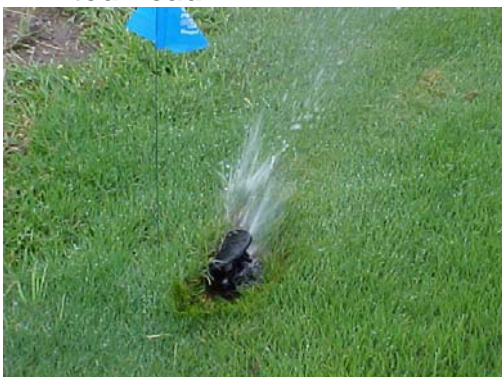
- **Tilted sprinkler heads.** When heads are tilted just a few degrees it can seriously affect the radius of the spray. The top of the sprinkler head should be nearly at and parallel to grade.

Tilted head

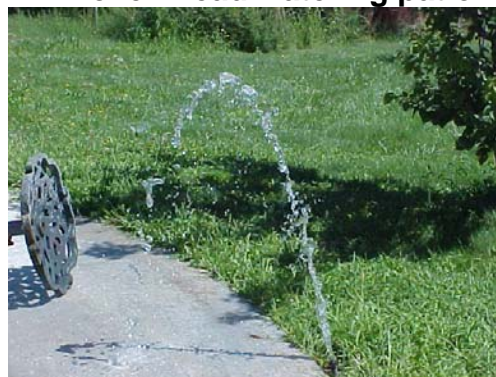
Broken head watering patio
