**The 2007 Mesa County
Irrigation Audit Program
Tri River Area
Final Report**

**Dr. Curtis E. Swift, Colorado State University Extension Agent & Certified Landscape Irrigation Auditor and
Ardith Blessinger, Certified Landscape Irrigation Auditor**

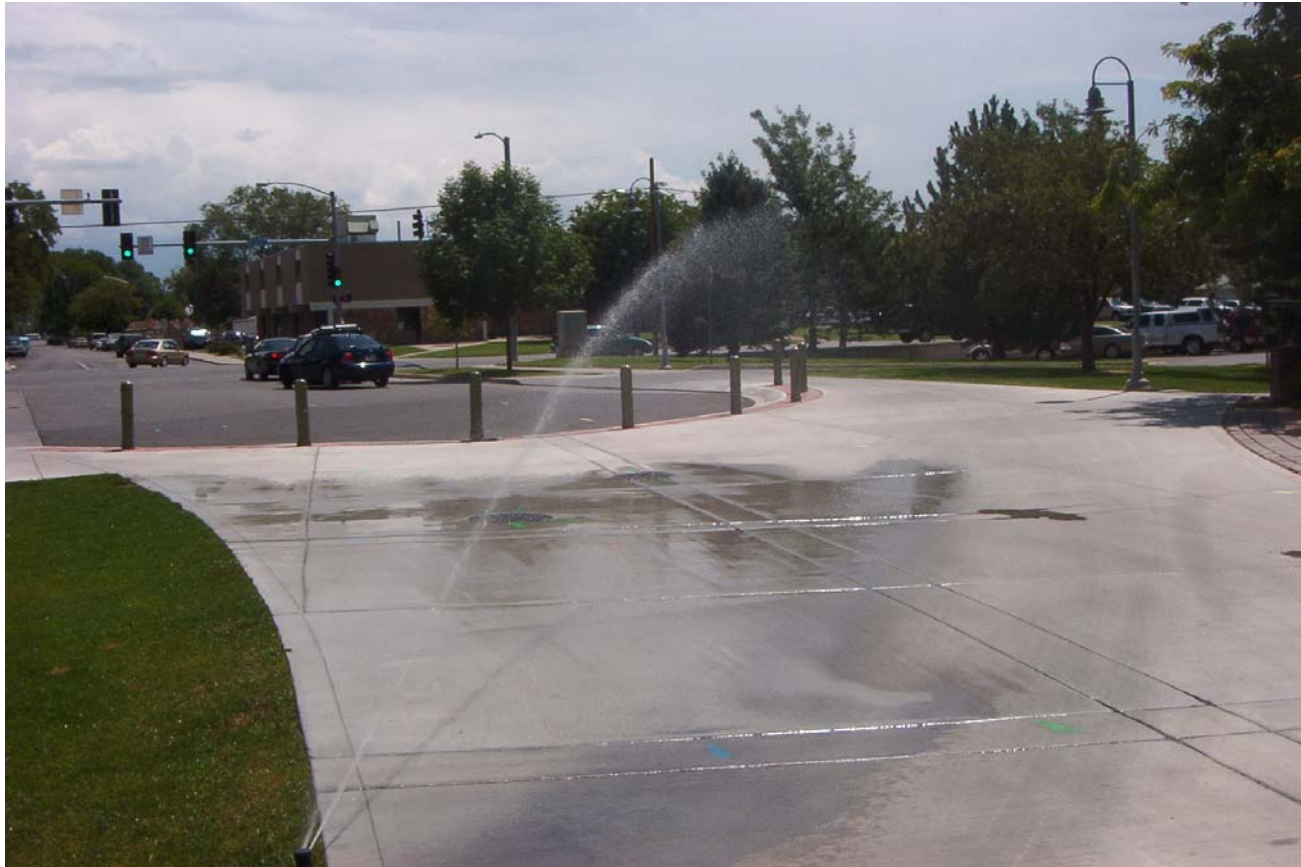
Culinary water used to irrigate the sidewalk

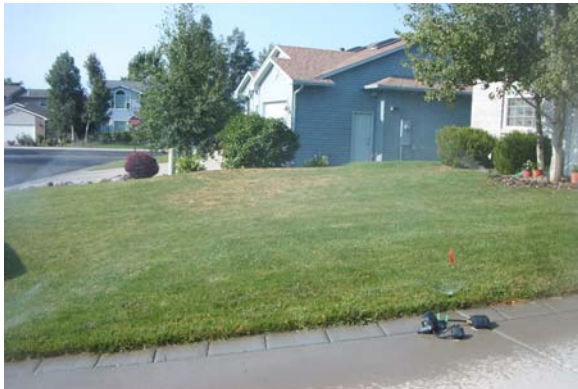
- Improper spacing caused problems for a few people. Trying to save money by installing fewer heads is not the answer. There should be head to head coverage, meaning the spray from any given head should touch of the adjacent heads, not meet in the middle. This allows for optimum overlapping coverage resulting in fewer dry areas.

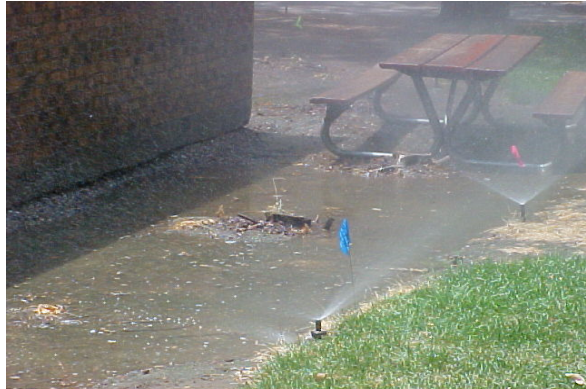
Incorrect nozzles

- Wrong size spray, rotor and impact head nozzles. Pop-up spray, rotor and impact heads have nozzles designed to be site specific. Many areas had the same size nozzle on every spray head whether the distance between heads was four feet or 15 feet. Nozzles on impact heads and rotors should match the area they are covering. A head rotating in a full circle would need a larger nozzle than one rotating in a half circle. The head rotating in a full circle will receive half as much water over any given area than one rotating in a half circle if they both have the same size nozzles.

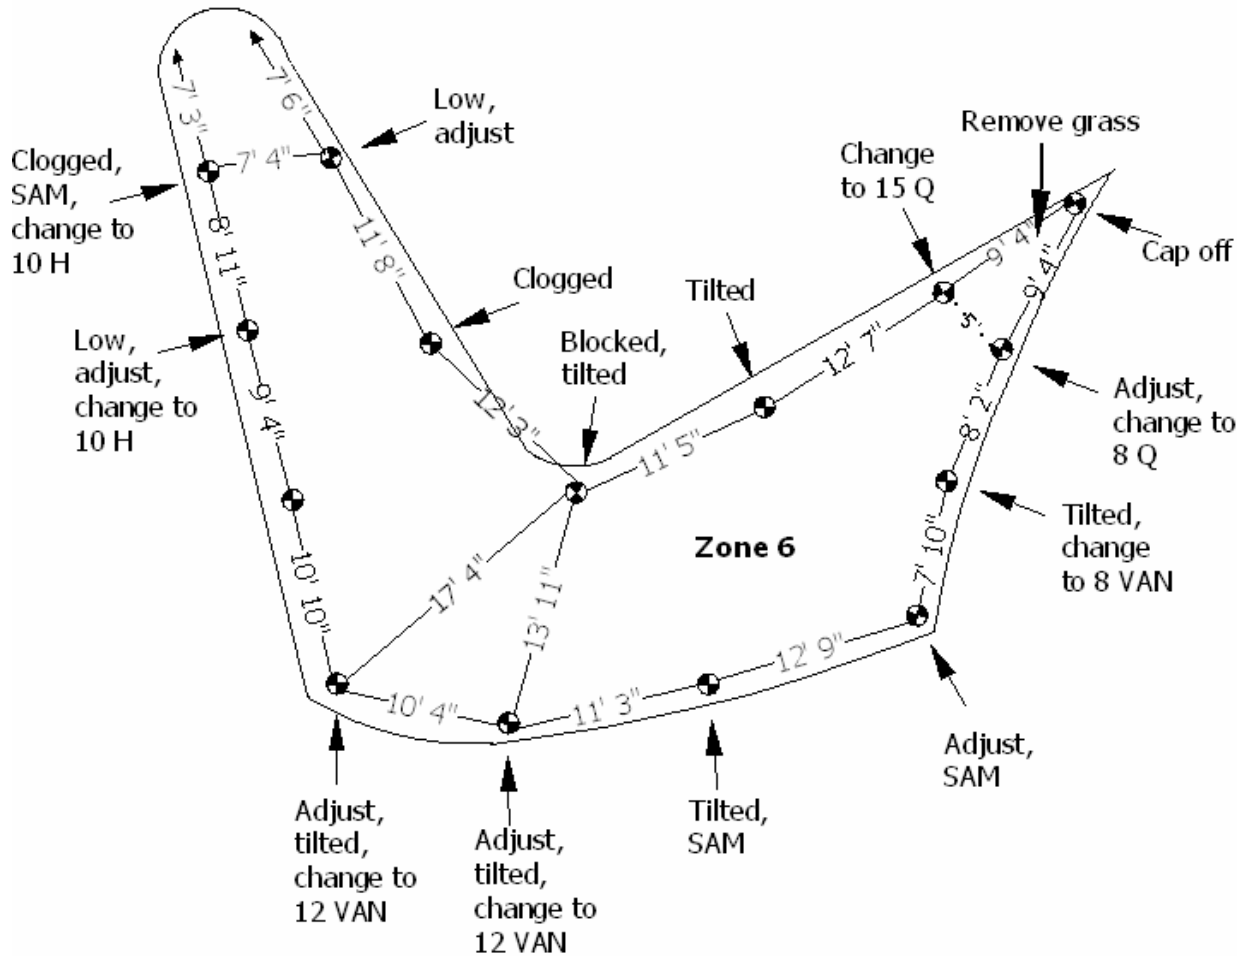
Sample Map

- Your system consists of 6 zones for the turf areas (zones 3, 4 and 6 - 9.)
- Many heads are tilted, low or need adjustment.
- One head should be changed from a full circle to a half circle.
- Several full circle heads should be changed to rotate in a clock wise direction. All are indicated on the enclosed maps.
- Grubs were found throughout the turf.

- Tilted sprinkler heads indicated on the map need to be straightened. When heads are tilted just a few degrees it can seriously affect the radius. The top of the sprinkler head should be nearly at and parallel to grade.

- Low heads should be raised enough so the spray does not hit the lawn directly in front of them. An easy way to tell if the sprinkler head is too low is by the presence of a “frog eye” pattern around the head. The blades of the grass will be pushed flat from the force of the water hitting them. When the spray cannot clear the plant material, it results in a broken spray pattern. Some areas will not receive adequate water and pooling occurs at the head.

- The heads in need of adjustment should be rotated to cover the edges of the lawn and not spraying the hardscape or other unwanted areas.
- The heads that rotate in a counter clock wise direction should be changed to rotate clockwise for a better matched precipitation rate with the other heads. To do this, while the zone is running, stop the head, lower the trip spring and let the head start rotating again. When the head stops on the friction spring and starts rotating in a clockwise direction, stop the head again and raise the trip spring. It will now rotate in a clockwise direction.
